TS-PIC-89790
September 1989

AERIAL PHOTOGRAPHIC ANALYSIS OF THE MADISON MINE COMPLEX Fredericktown, Missouri

EPA Region 7

Superfund

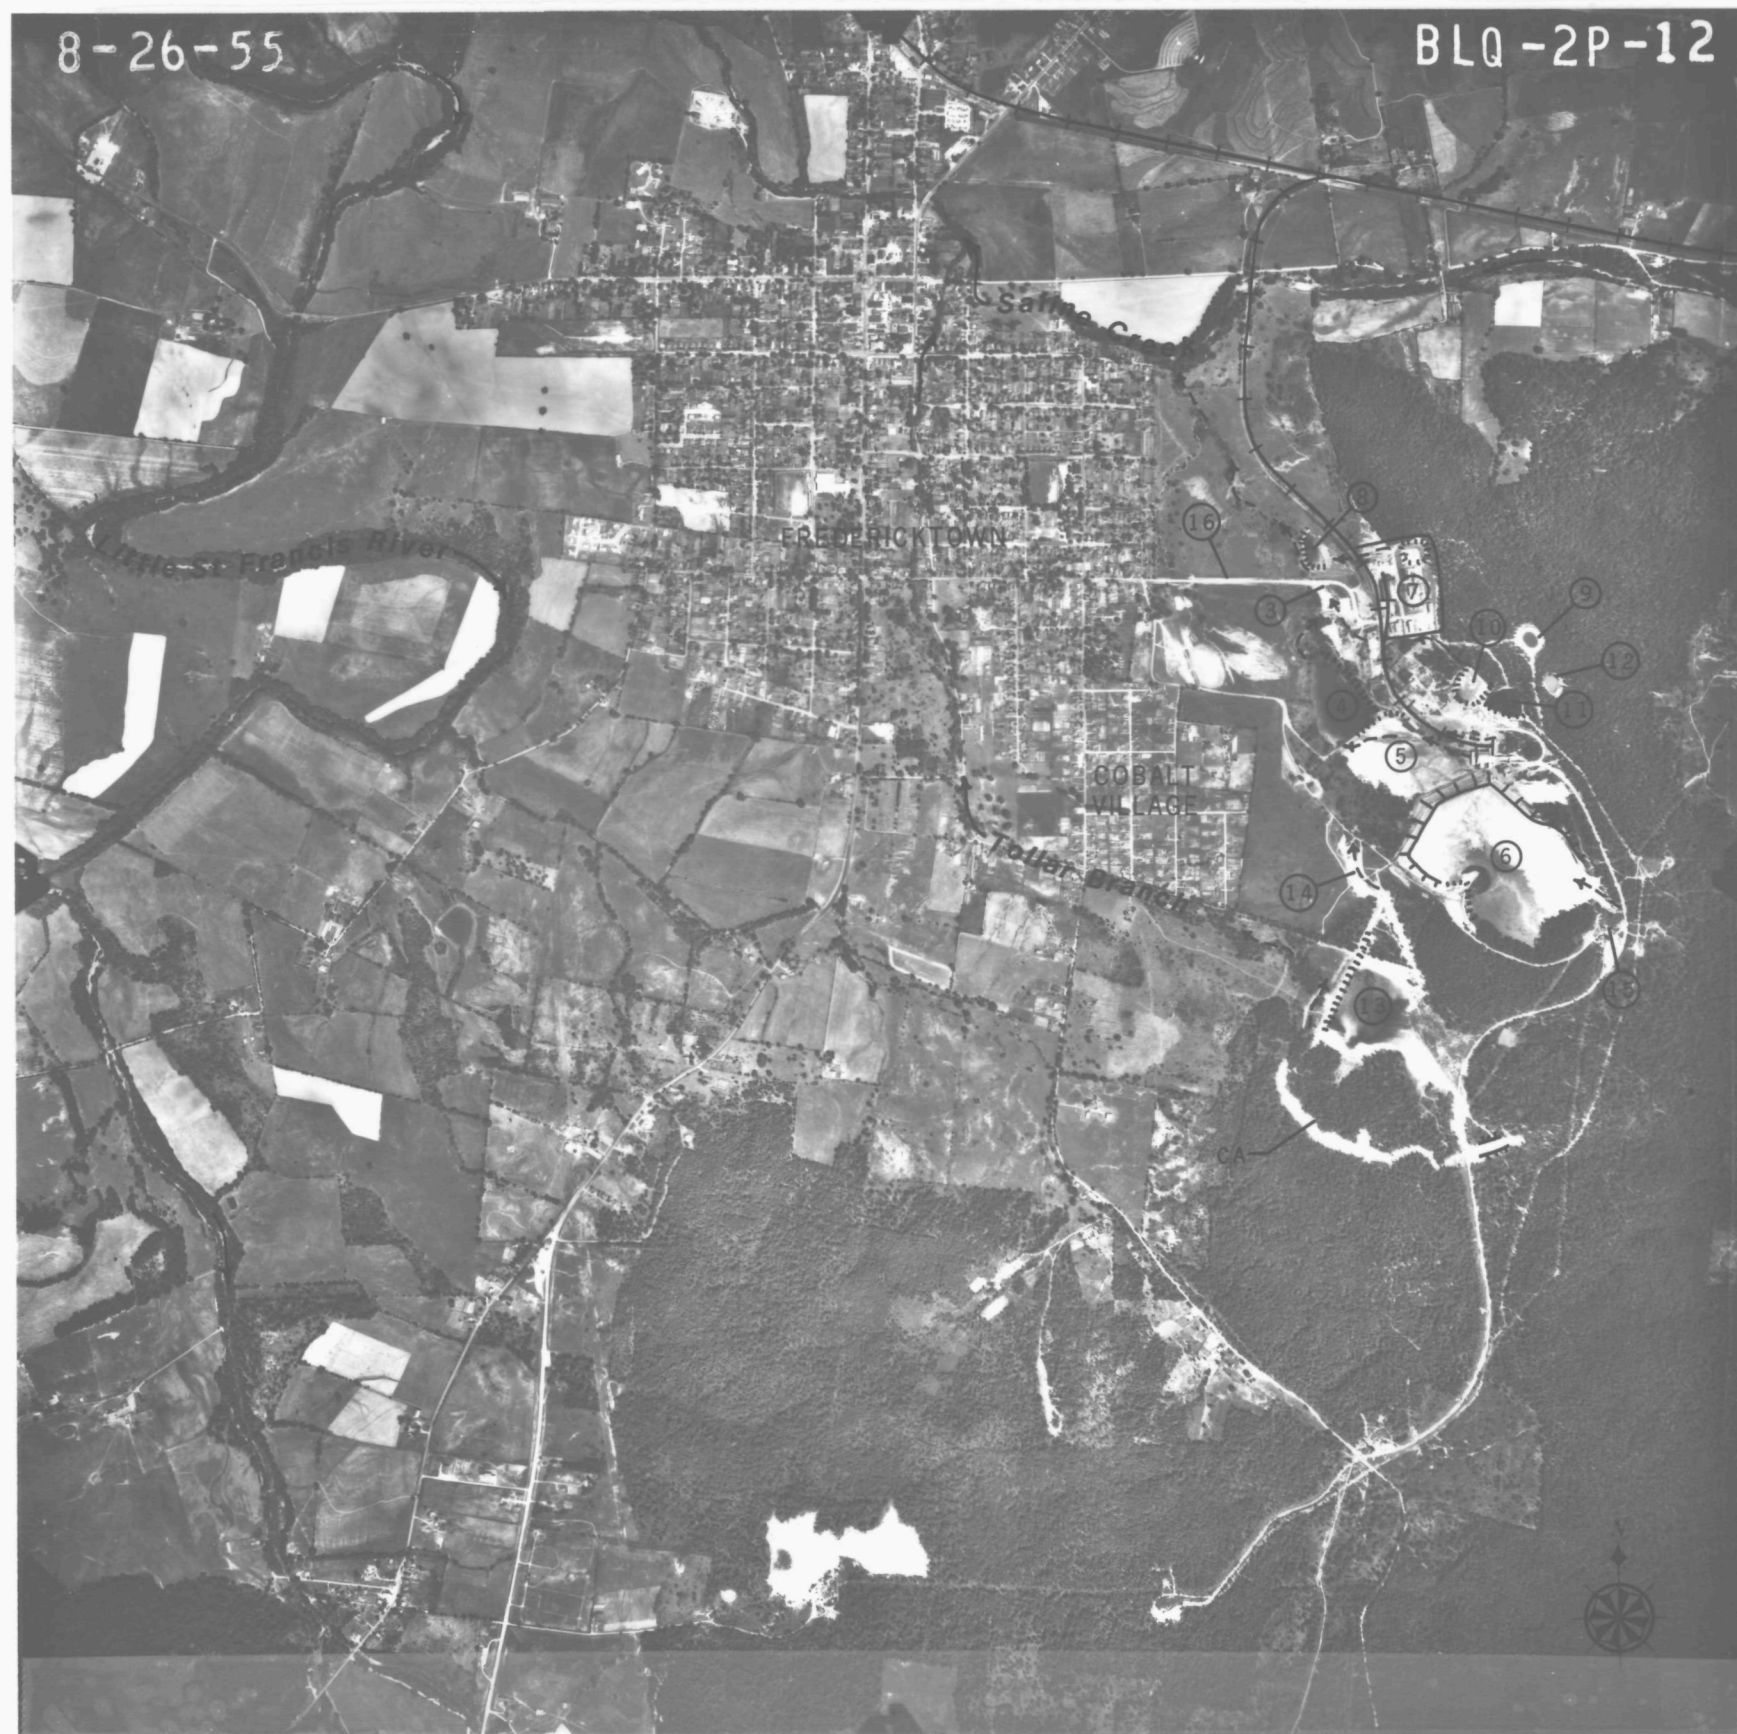
Figure 4. Madison Mine, August 26, 1955. Approximate scale 1:21,300.

Extensive changes have occurred at the Madison Mine since the photo coverage of March 2, 1939, including the presence of new ponds, impoundments, tailings, and an additional ore processing area. Some of the older facilities have been demolished.

There are no signs of the solid waste previously located at Annotation 3. This area is now level and barren. The only change to the tailings pond at Annotation 4 is the build-up of sediment at its south end where liquid from the tailings of Annotation 5 are released into the pond. The stained drainage pattern atop the tailings of Annotation 5 shows that liquid coming from the buildings at the end of the rail line is traveling into the pond at Annotation 4. The new tailings at Annotation 6 has a pipeline extending along its northeastern and northwestern edges that originates in the building at the end of the rail line. The new mill works that has been constructed at Annotation 7 has four vertical tanks that are uncontained and one that is contained. There is a small drainage ditch along the northern edge of this area that leads to a new impoundment at Annotation 8. Annotation 9 is a new pond that appears to be lined. The new unlined ponds located at Annotations 10 and 11 are both filled to capacity; Annotation 10 with sludge and Annotation 11 with a dark colored liquid. There has been no visible change to the pond at Annotation 12. An earthen dam has been built across the drainage into Tollar Branch creating the impoundment at Annotation 13. A drainage ditch (Annotation 14) is being excavated from the north end of this area and leading into the tailings at Annotation 5. There is a cleared area along the side of the hills south of the impoundment that leads to another earthen dam under construction. Annotation 15 is the location of a small group of newly erected buildings, and Annotation 16 is the new access road to the Madison Mine complex.

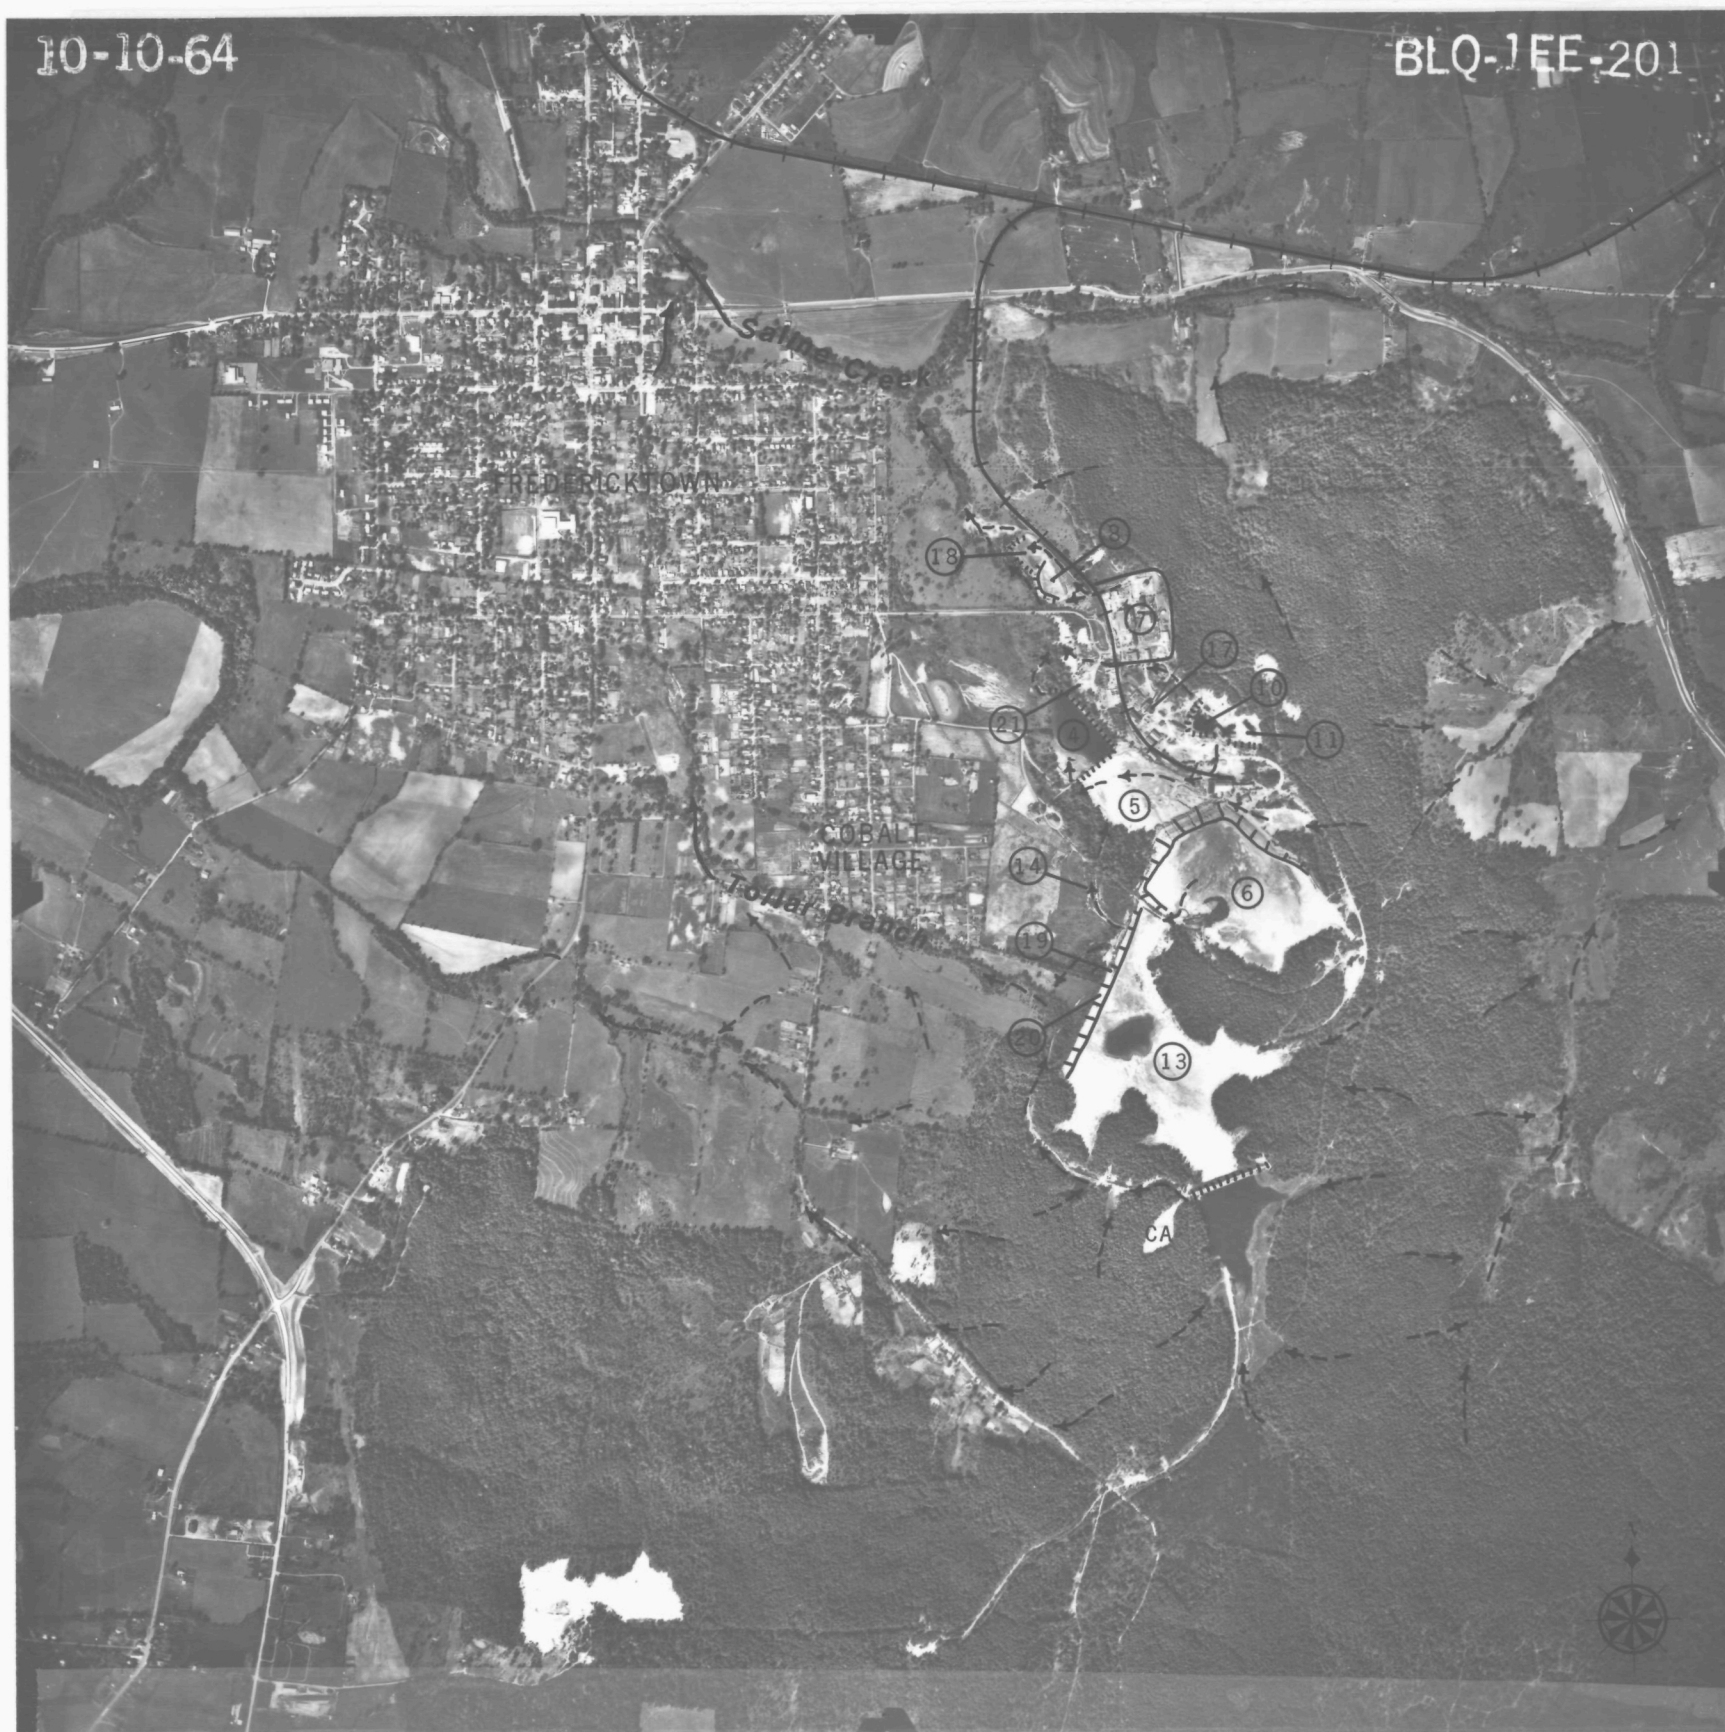
Figure 5. Madison Mine, October 10, 1964. Approximate scale 1:21,300.

The quantity of sediment at the south end of the tailings pond (Annotation 4) has increased, and appears to be the result of runoff passing through the tailings of Annotation 5. The build-up at the east end of the tailings (Annotation 5) appears to be the accumulation of erosion that is occurring along the face of the tailings located at Annotation 6. The drainage ditch leading from the mill works of Annotation 7 now passes around the south side of the impoundment at Annotation 8, which is filled with sludge, and enters the stream leading to Saline Creek. This ditch forks at the railroad tracks and the northern fork leads to a new impoundment at Annotation 18. There is a visible trail of previous releases from the northern corner of this impoundment that leads into the stream leading to Saline Creek. Most of the sludge previously located in the pond at Annotation 10 has been removed. There is a trail leading from this pond's northern edge that appears to be the track of previously released liquid which traveled to the stream that leads to Saline Creek. The southwestern wall of the pond at Annotation 11 appears to have been breached and temporary repairs made. There are piles of what appears to be sludge all along the southwestern walls of the ponds at Annotations 10 and 11, and there is a trail of staining leading from the breach area, through the tailings of Annotation 5 to the tailings pond at Annotation 4. The staining also enters the drainage system leaving the site. The earthen dam has been completed at the south end of the tailings located at Annotation 13. A drainage ditch has been dug from the western edge of this dam, around the south side of the tailings to Tollar Branch. Along the face of these tailings are located an area of seepage (Annotation 19) and an area of erosion (Annotation 20). Both of these areas lead directly to Tollar Branch. The drainage ditch (Annotation 14), leading from the face of the tailings to the tailings at Annotation 5, has been completed. Annotation 21 is an area previously occupied by small impoundments where a small amount of solid waste dumping has occurred.

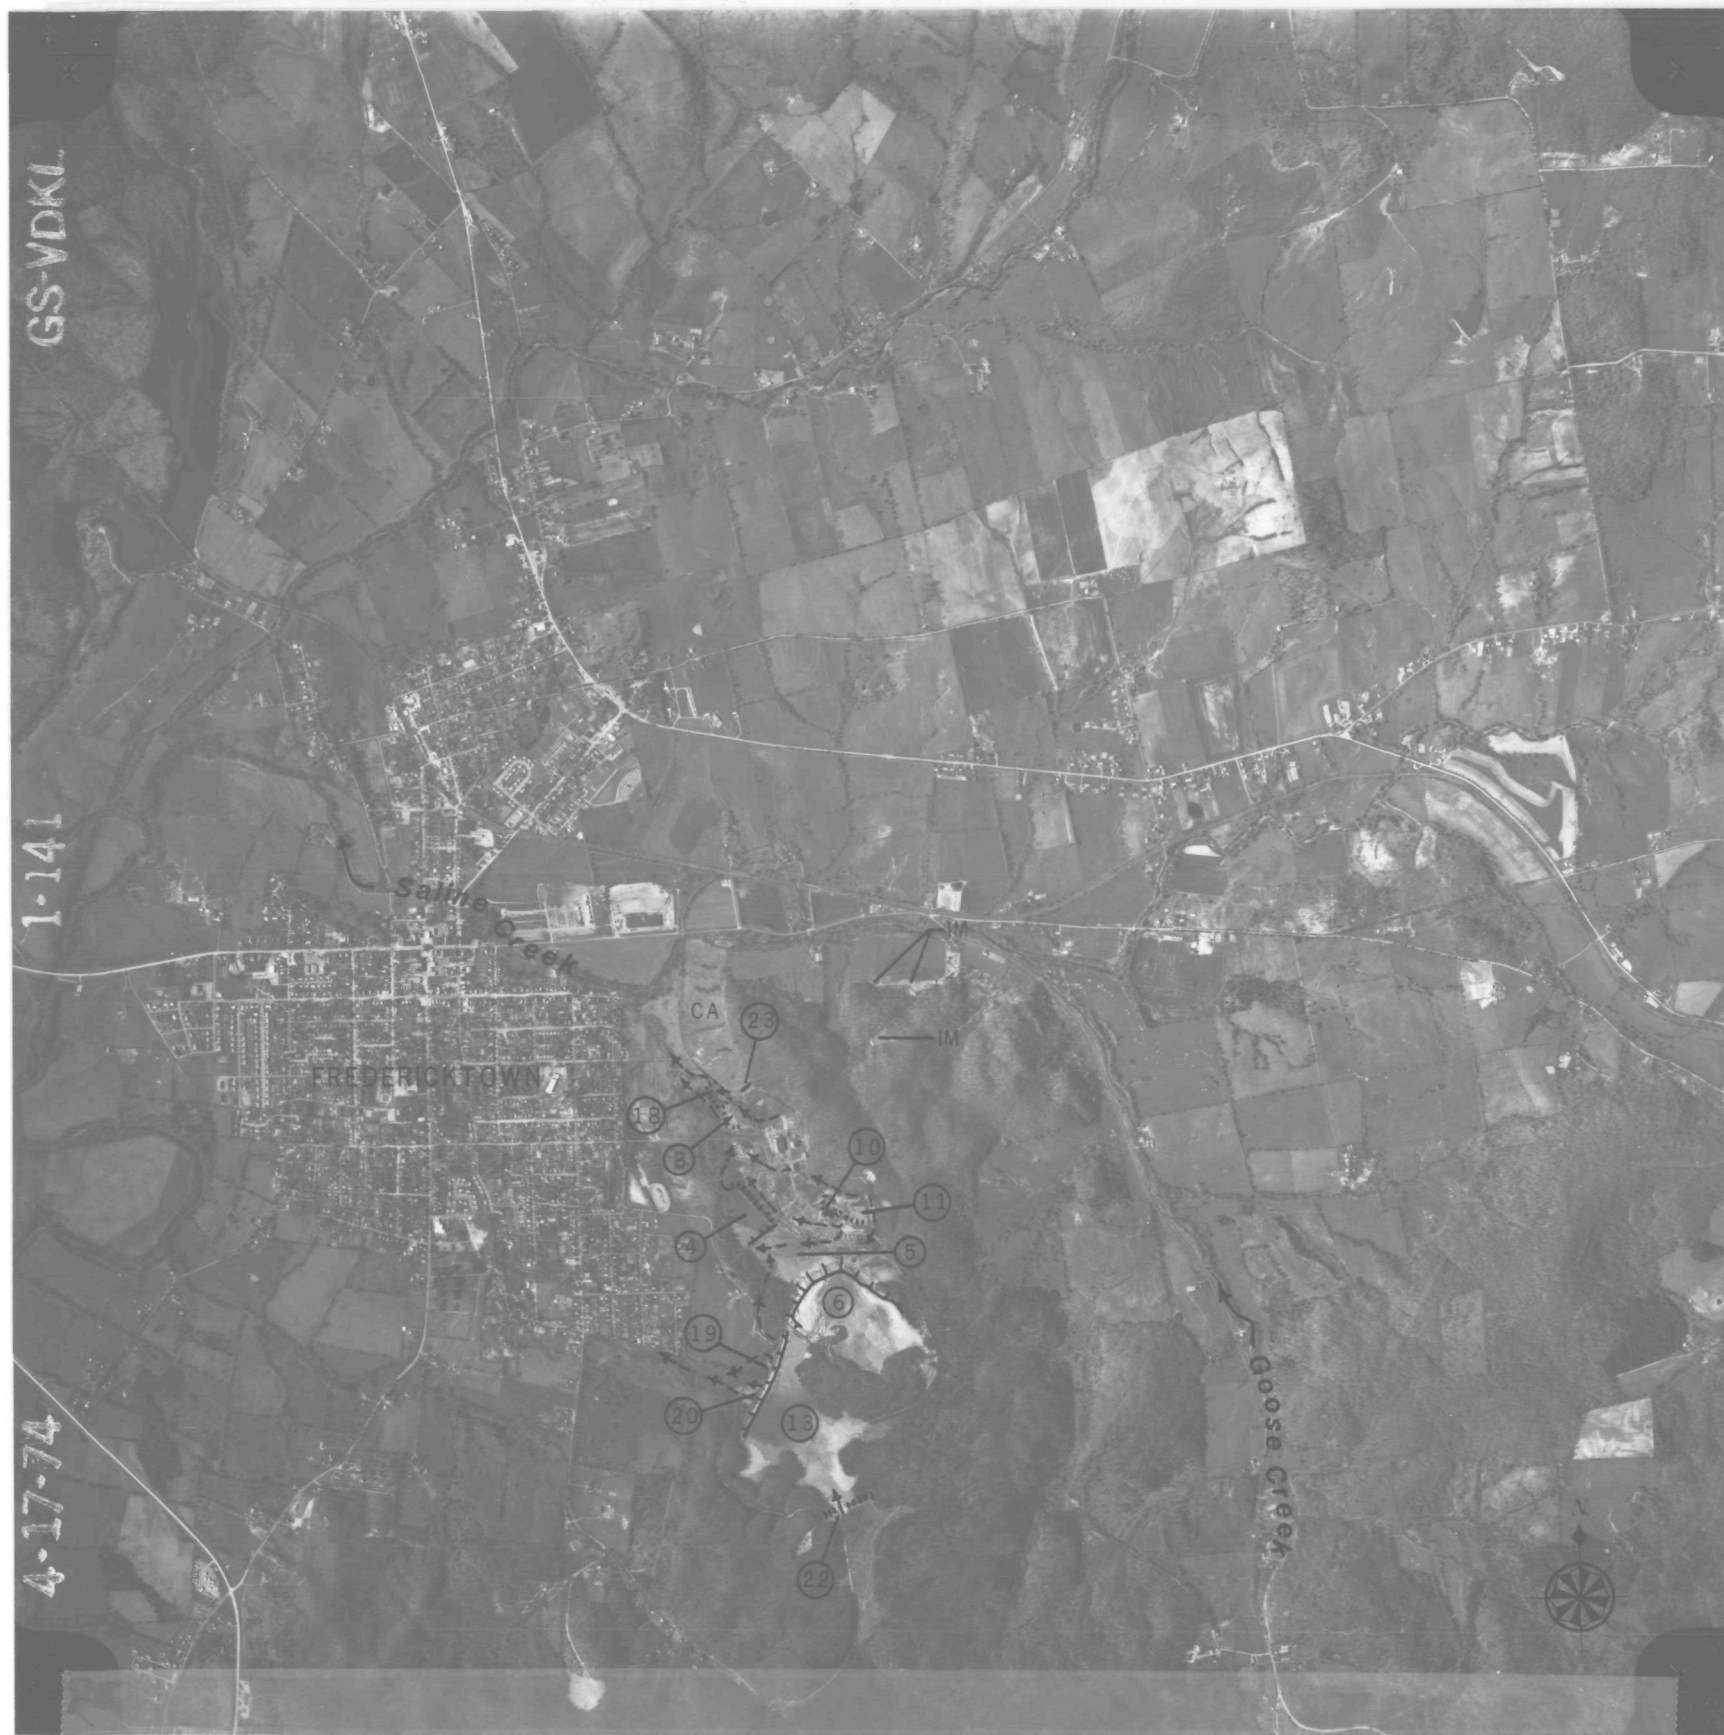
Figure 7. Madison Mine, April 17, 1974. Approximate scale 1:33,200.

All of the buildings at the Madison Mine complex except those located at Annotation 7, have been demolished. All of the tanks have been removed from the area of Annotation 7, and there is visible staining at the south end of the largest building in this area. The impoundments located at Annotations 8 and 18 appear unchanged, as do the tailings pond and tailings of Annotations 4, 5, and 6. There is a breach in the wall of the pond at Annotation 11 and a trail showing the ponds contents traveled through the tailings of Annotation 5 to the tailings pond of Annotation 4. Along the face of the tailings (Annotation 13) are still located an area of seepage at Annotation 19 and an area of erosion at Annotation 20. The area between the erosion activity and Tollar Branch is now barren.

There has been very little change at the Madison Mine complex since the photo coverage of May 14, 1971 (Figure 6). The erosional activity along the face of the mine tailings of Annotation 6 has continued to fill the tailings of Annotation 5 that releases excess liquids into the tailings pond (Annotation 4). A majority of the sludge previously located in the impoundment at Annotation 8 is no longer visible. The impoundment located at Annotation 18 is partially filled with liquid that may have come from the mill works area (Annotation 7) via the drainage ditch. To the east of this impoundment at Annotation 23 is located a trench that is possibly being used for waste disposal. Fill material is being dumped into the north end of the pond located at Annotation 10. The breach in the southern wall of the pond at Annotation 11 has again been temporarily repaired, and there is mounded material inside the pond adjacent to a pit that has been excavated adjacent to the repaired breach. A diversionary ditch has been excavated on the uphill side of both ponds to direct runoff around the ponds and into the drainage system leading to Saline Creek. A majority of the tailings at Annotation 13 are submerged by water, previously held by the earthen dam at the south end of the tailings. An intentional cut appears to have been made in the dam allowing all the water to escape. The seepage is still visible on the face of these tailings at Annotation 19, and the erosion activity at Annotation 20 has spread.

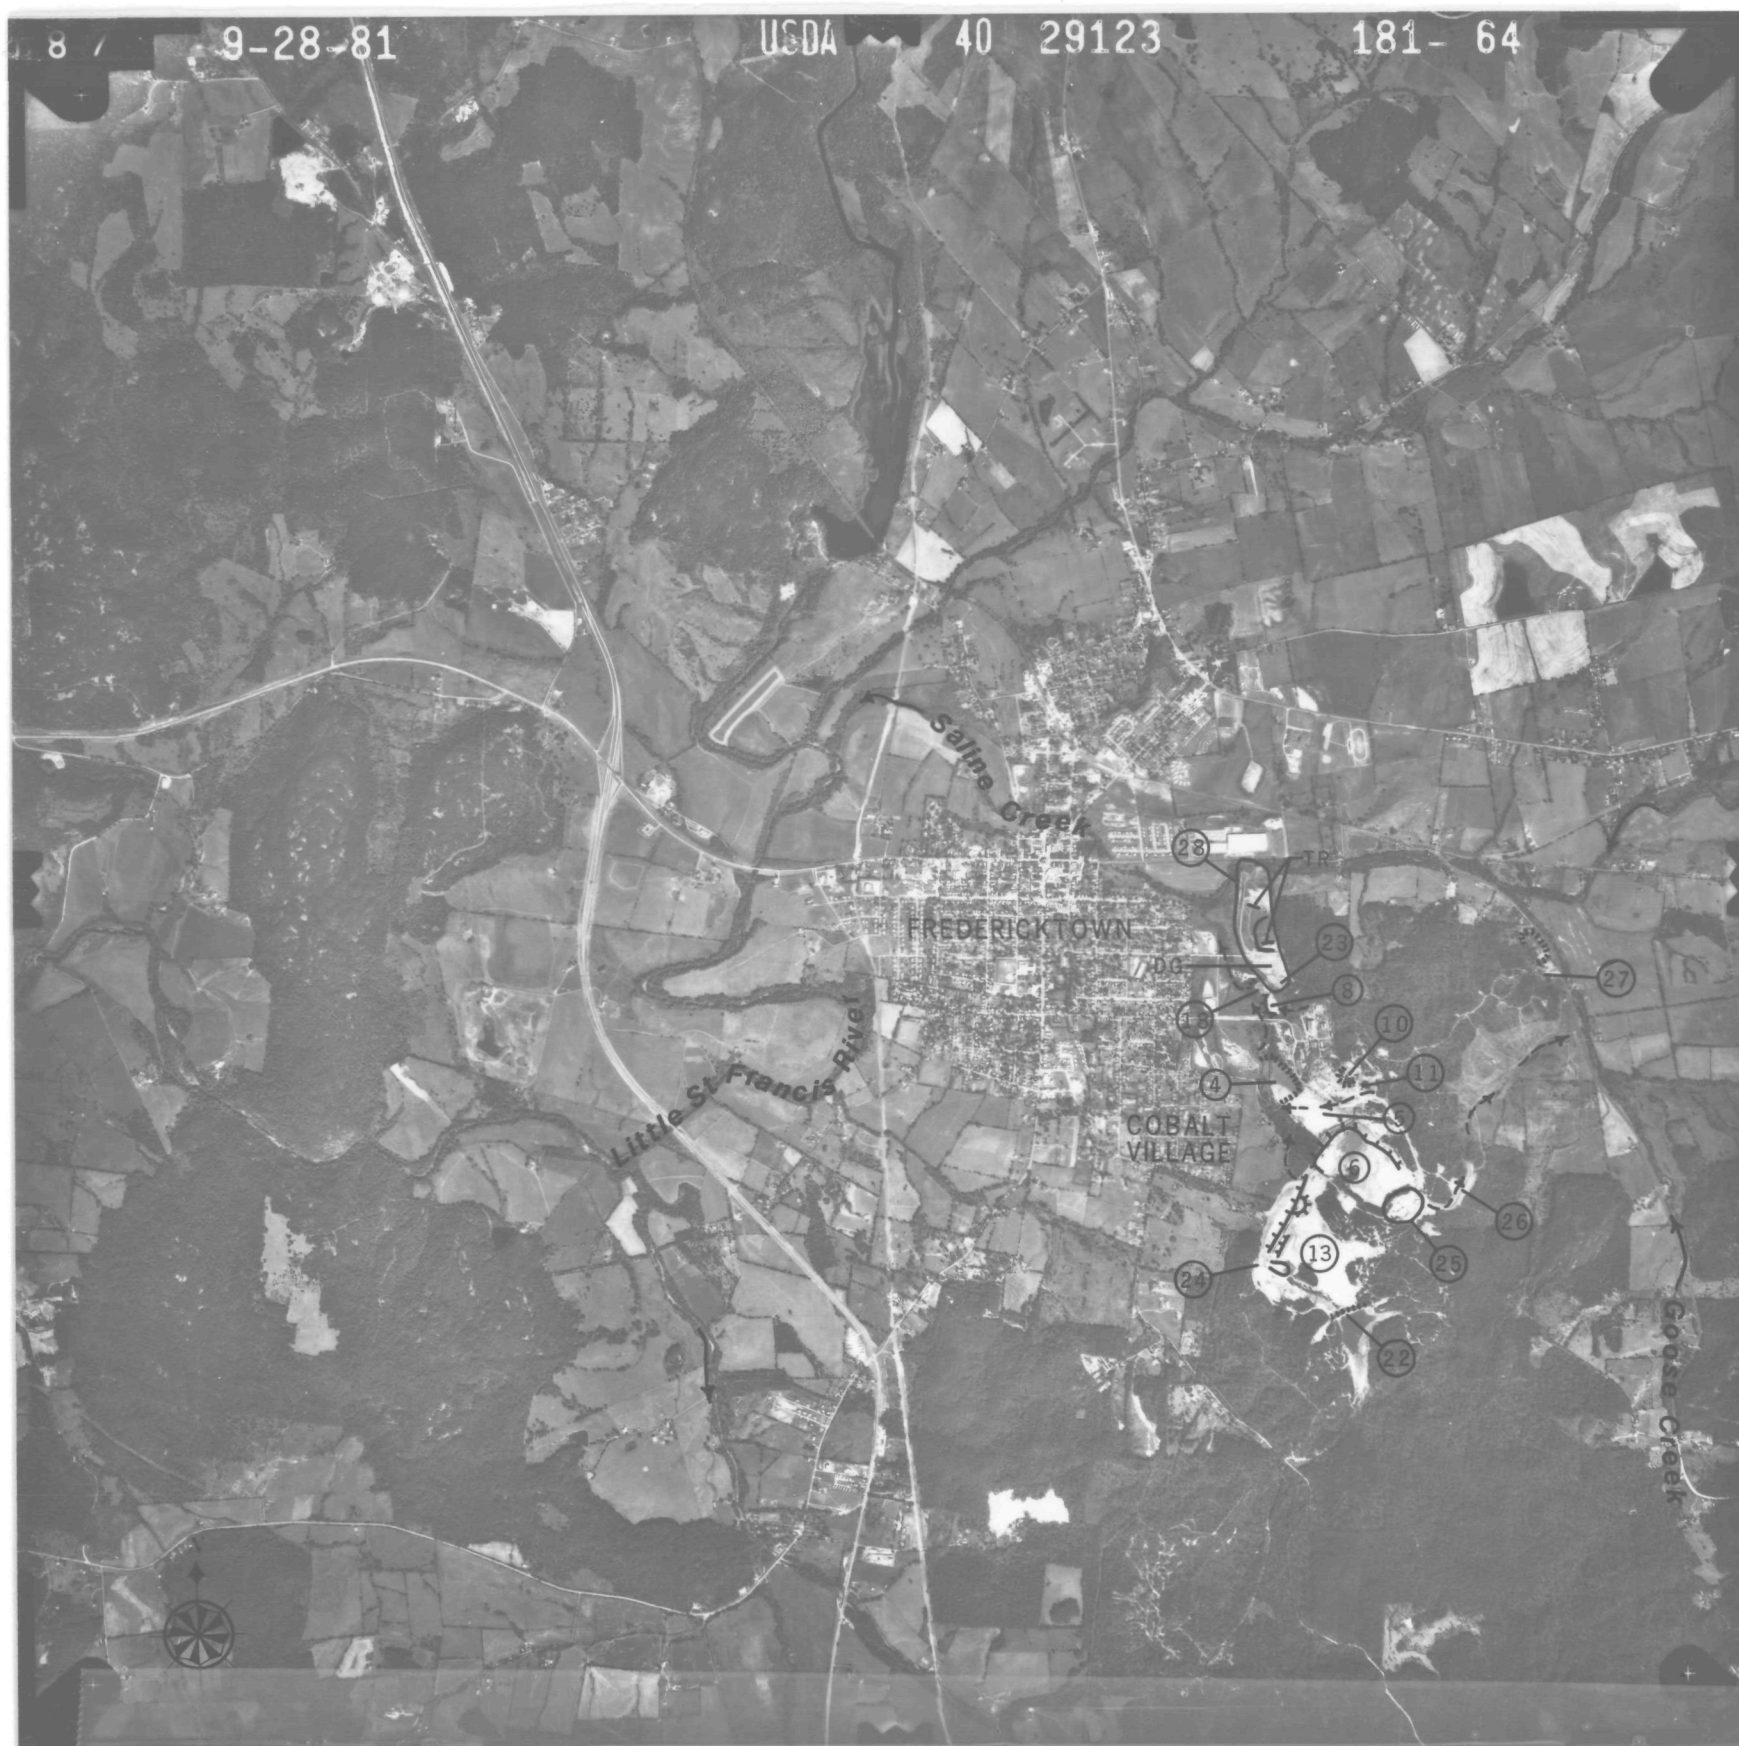
Figure 8. Madison Mine, September 28, 1981. Approximate scale 1:43,400.

The impoundments located at Annotations 8 and 18 and the pond at Annotation 10 have the same basic appearance as shown on the photo coverage of April 17, 1974 (Figure 7). There is now a second breach in the southern containment wall of the pond located at Annotation 11. There is a trail left by the liquid released through this breach that travels through the tailings of Annotation 5 to the entrance of the tailings pond at Annotation 4. The erosion activity has continued along the face of the tailings at Annotation 6 where there are now many deep gullies. There has been a new group of four buildings constructed on a small knoll at Annotation 25, and a discharge pipe coming from underground empties into the newly constructed drainage ditch (Annotation 26) which empties into the natural drainage system leading northeast to Saline Creek. Extensive modifications are in progress on the face of the tailings located at Annotation 13. The earthen dam at Annotation 22 has been repaired and there are pieces of heavy equipment located at Annotation 24. Annotation 27 is a mine entrance and an empty pond that are directly linked to the site by dirt roads leading from the mine entrance to ponds at Annotations 10 and 11, and the newly constructed buildings at Annotation 25. There are three trenches located in the area of Annotation 28 and the trench previously reported at Annotation 23 has been filled. The disturbed ground in the southern portion of this area indicates more trenches may have been previously located here.

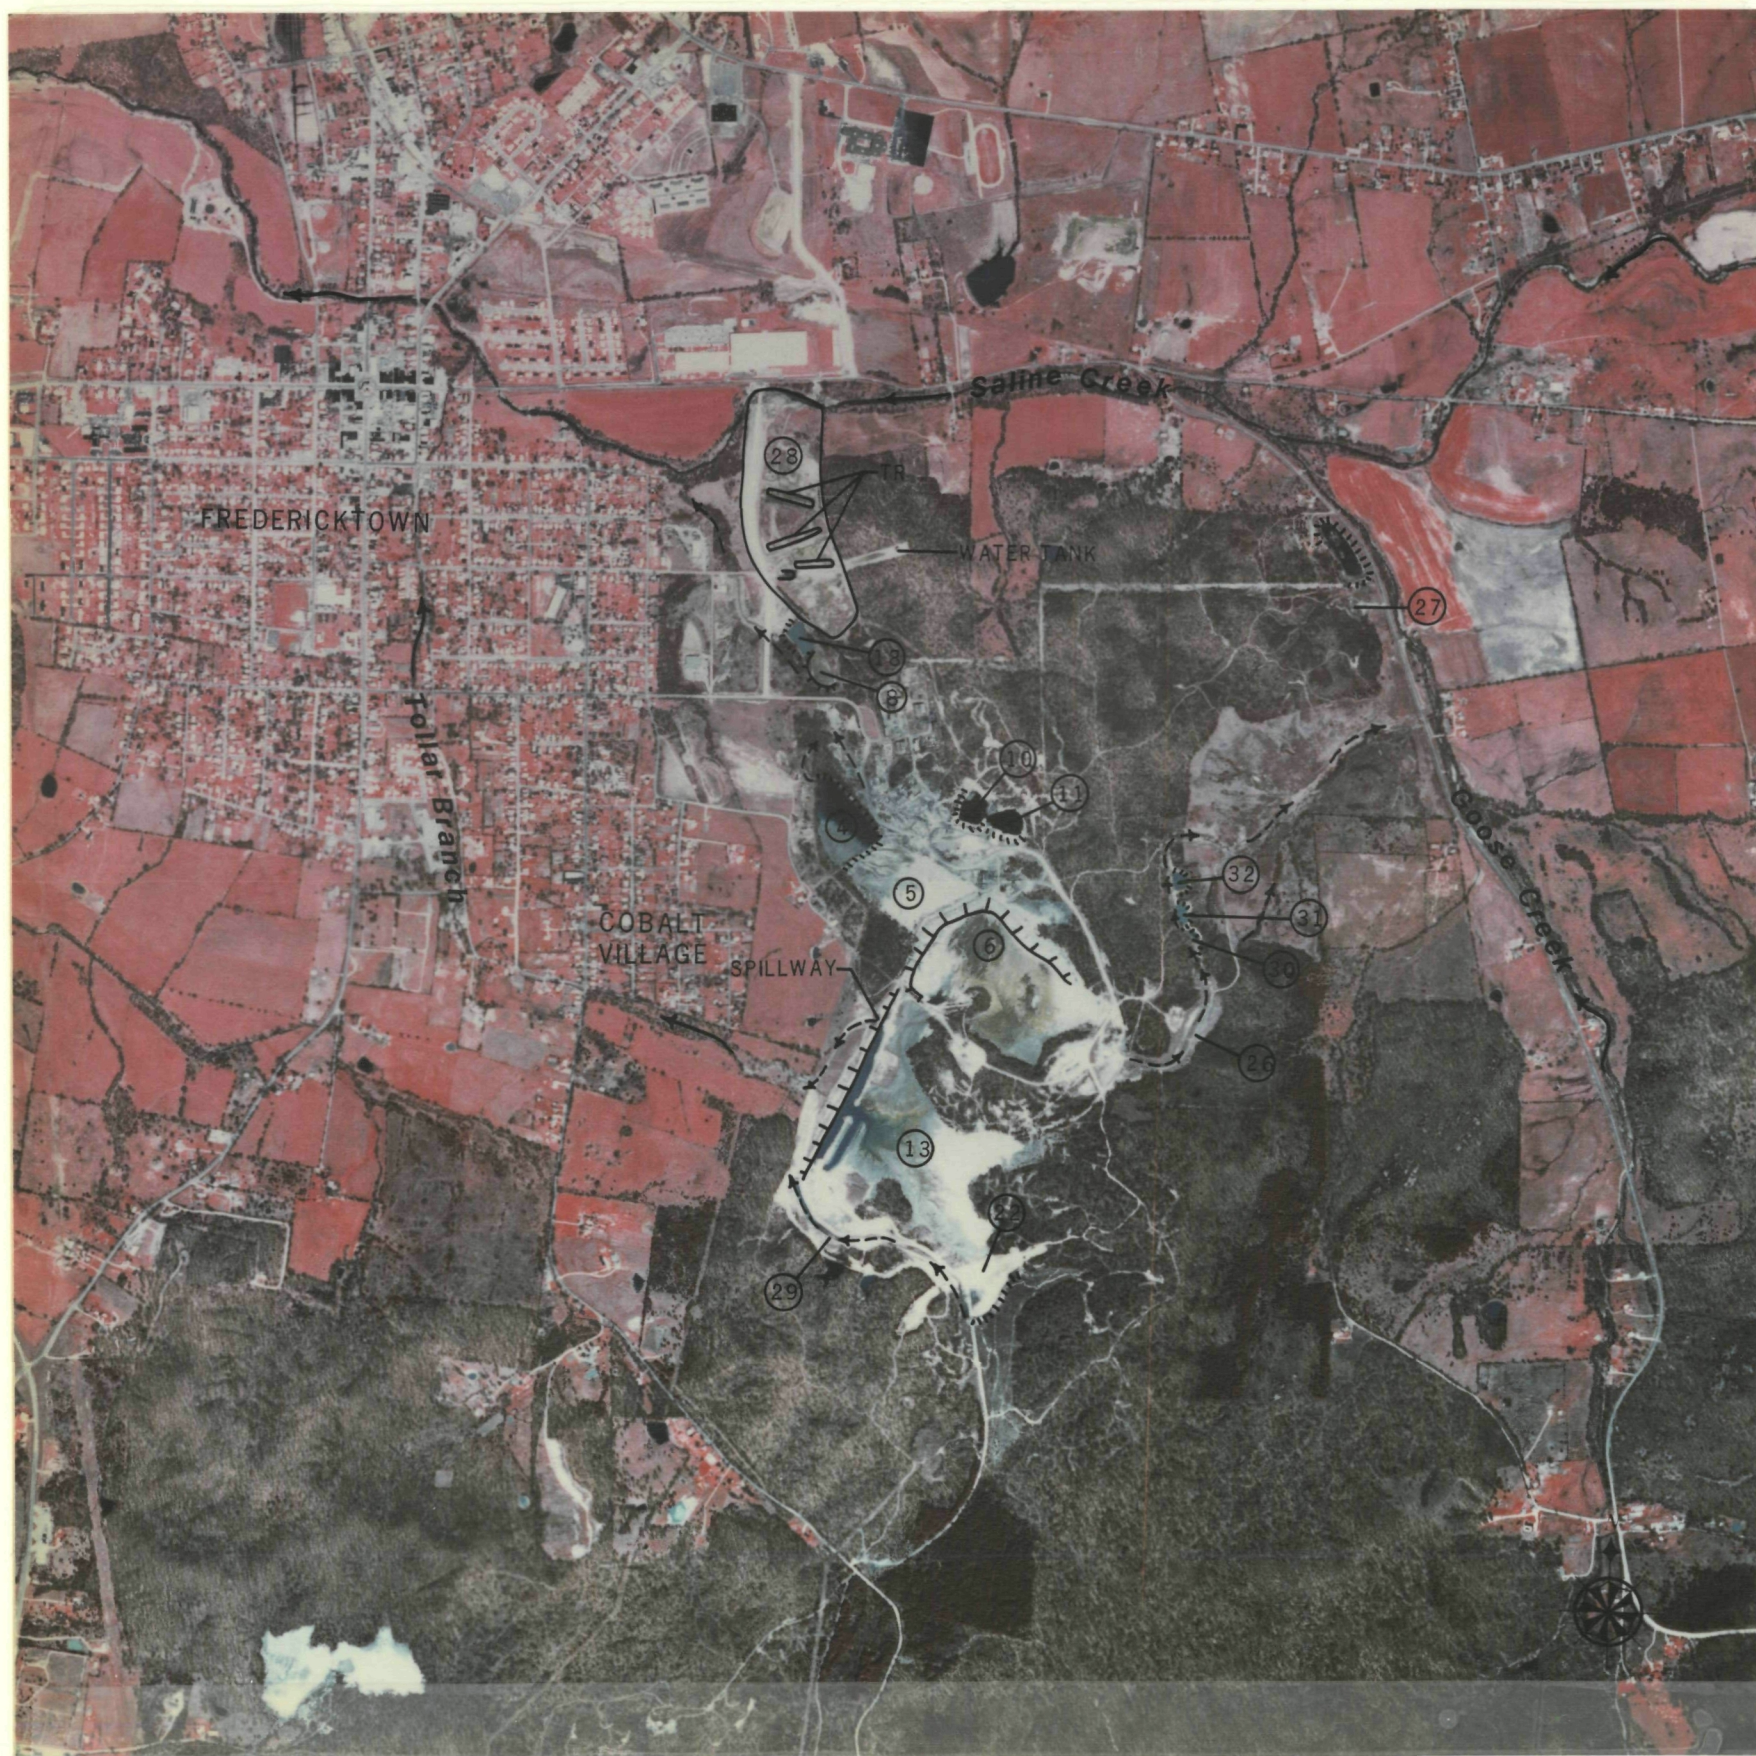
Figure 9. Madison Mine, April 18, 1984. Approximate scale 1:20,900.

There were no significant changes observed since the photo coverage of September 28, 1981 (Figure 8) at tailings pond (Annotation 4), tailings (Annotation 5), impoundments (Annotations 8 and 18) or the mine and pond at Annotation 27 in the Madison Mine complex. The erosion activity along the face of the tailings at Annotation 6 is continuing to enlarge the gullies. The breaches in the southern wall of the pond at Annotation 11 have been repaired and both ponds at Annotations 10 and 11 are filled with dark colored liquid. The work around the tailings at Annotation 13 has been completed. The earthen dam, previously located at Annotation 22, has been removed and a small dike created to the immediate south. A new drainage ditch that empties into Tollar Branch has been excavated along the southern edge of the tailings (Annotation 29). The drainage ditch at Annotation 26 has been extended to the north where it empties into a series of three newly created ponds (Annotations 30, 31, and 32) before releasing into the natural drainage system leading to Saline Creek. In the cleared area of Annotation 28 the previously reported two northern trenches have been filled and paralleling trenches excavated. There is an excavation near the southern trench that contains an unidentified dark colored substance.
